monmouthshire
sir fynwy

Monmouthshire County Council
Review of Landslips within the County
December 2013- February 2014

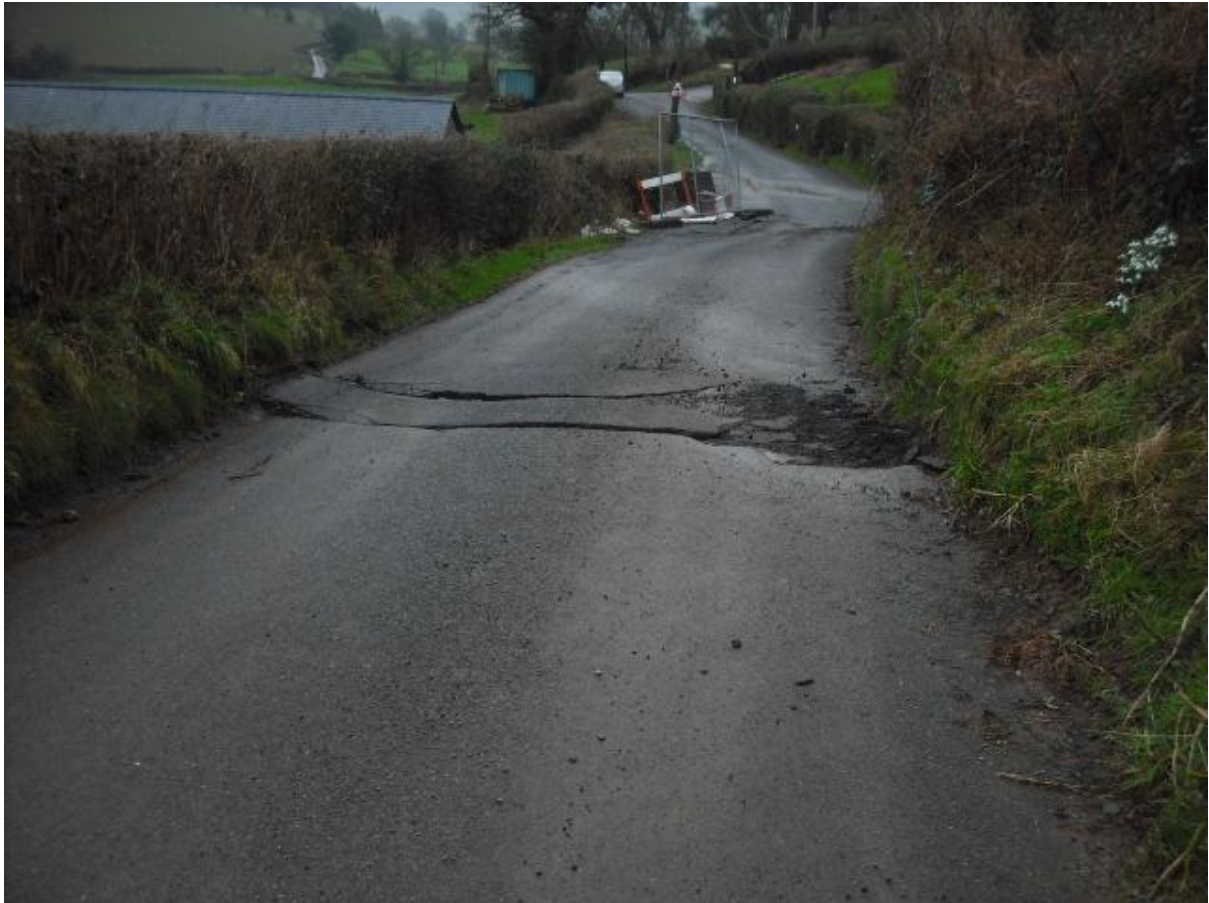
View looking South

This section of the B4347 has suffered from significant ground movements brought about by the extreme wet weather conditions experienced within the County. The road is closed to traffic. The retaining wall running parallel with the edge of the carriageway near the barn conversion in the background is also cause for concern.

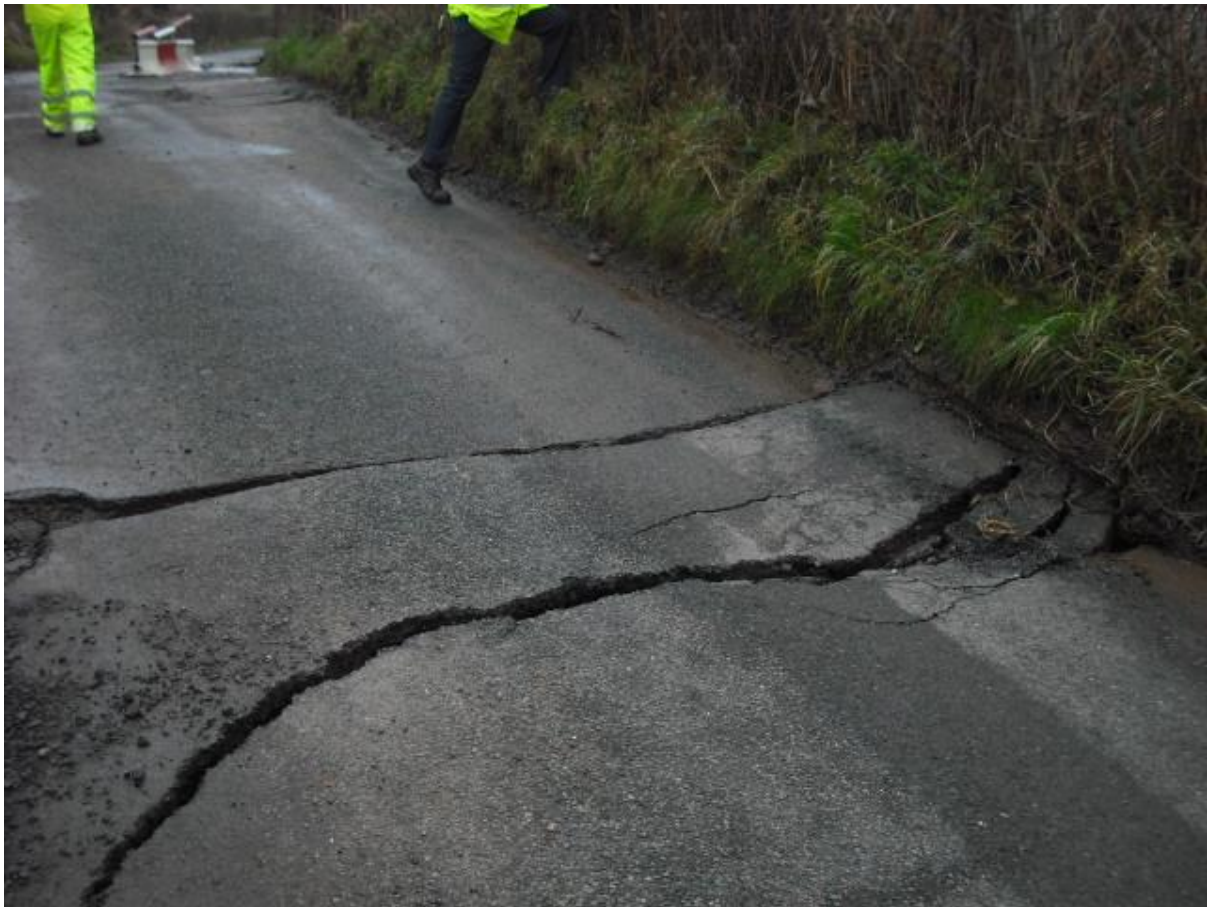
View looking North

The photograph shows detail of the failure present in the road. The road has been closed to traffic for safety reasons and the available diversions require the public to divert several miles. Repair cost estimates for this section of the B4347 are in the order of £62,000

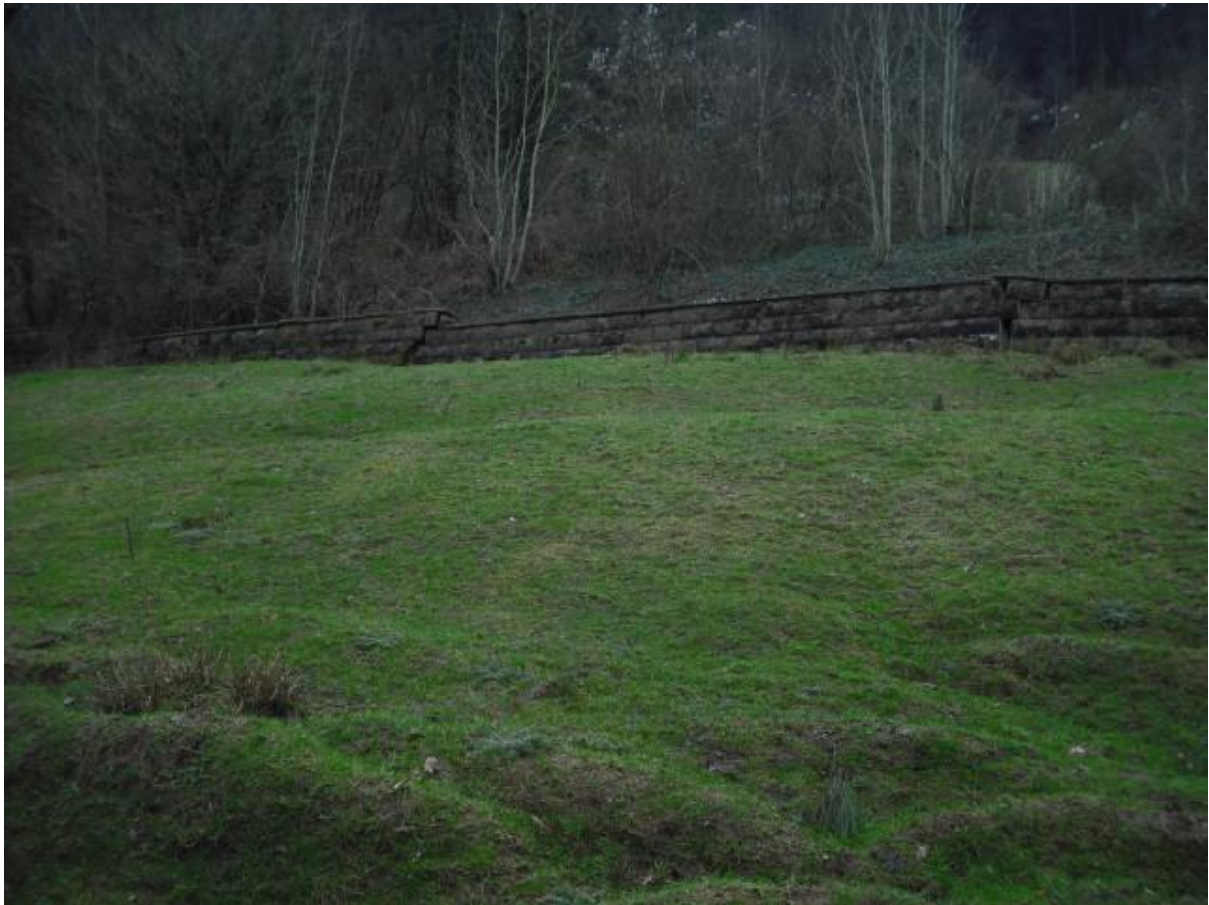
View looking West

On this section of the B4347 there has been settlement in excess of 1.0m. The ground movements have damaged the retaining wall causing shear failures at a number of locations along it. Edge support to the carriageway has been removed and there is tension cracking apparent in the surfacing. There is over 150m of retaining wall affected. Repair costs are in the order of £380,000

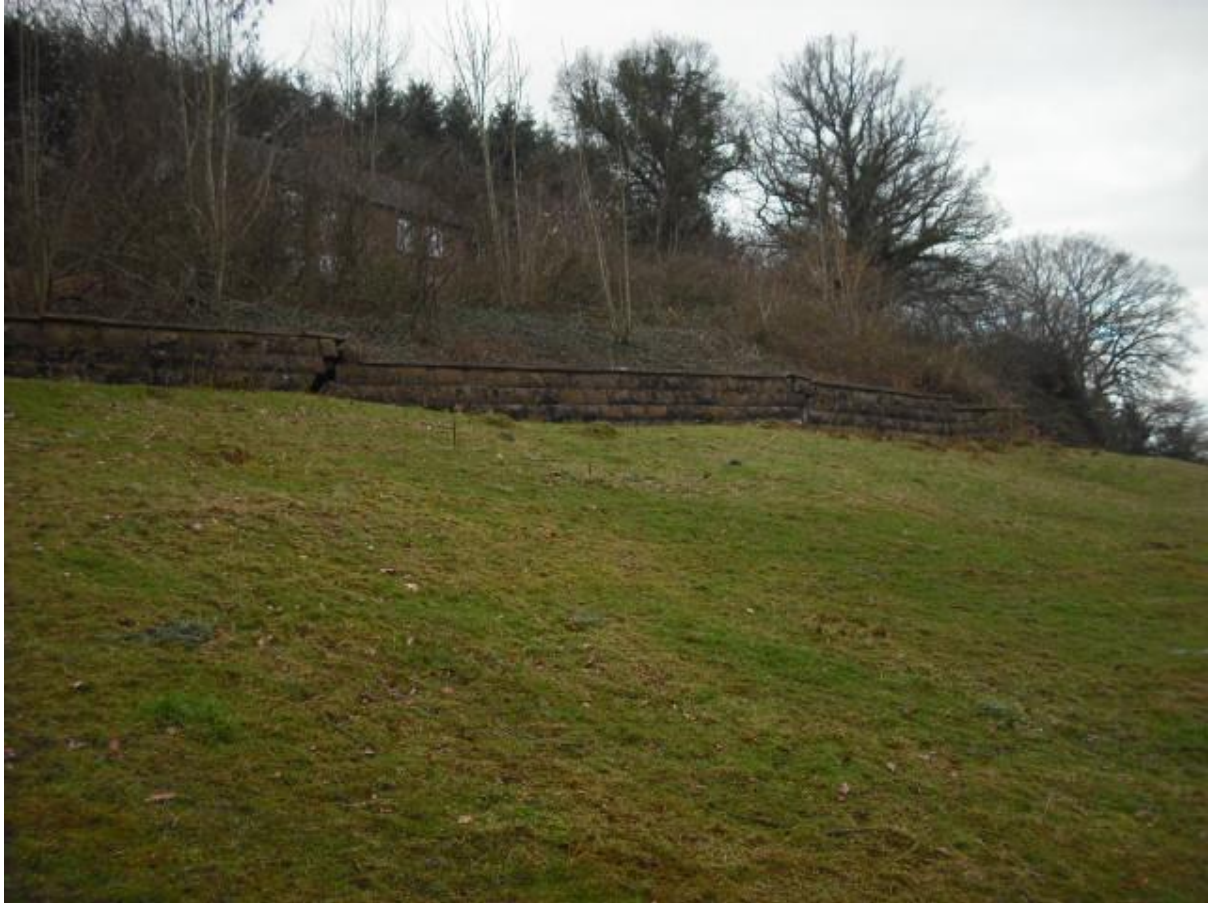
View looking West

Further view of retaining wall damage

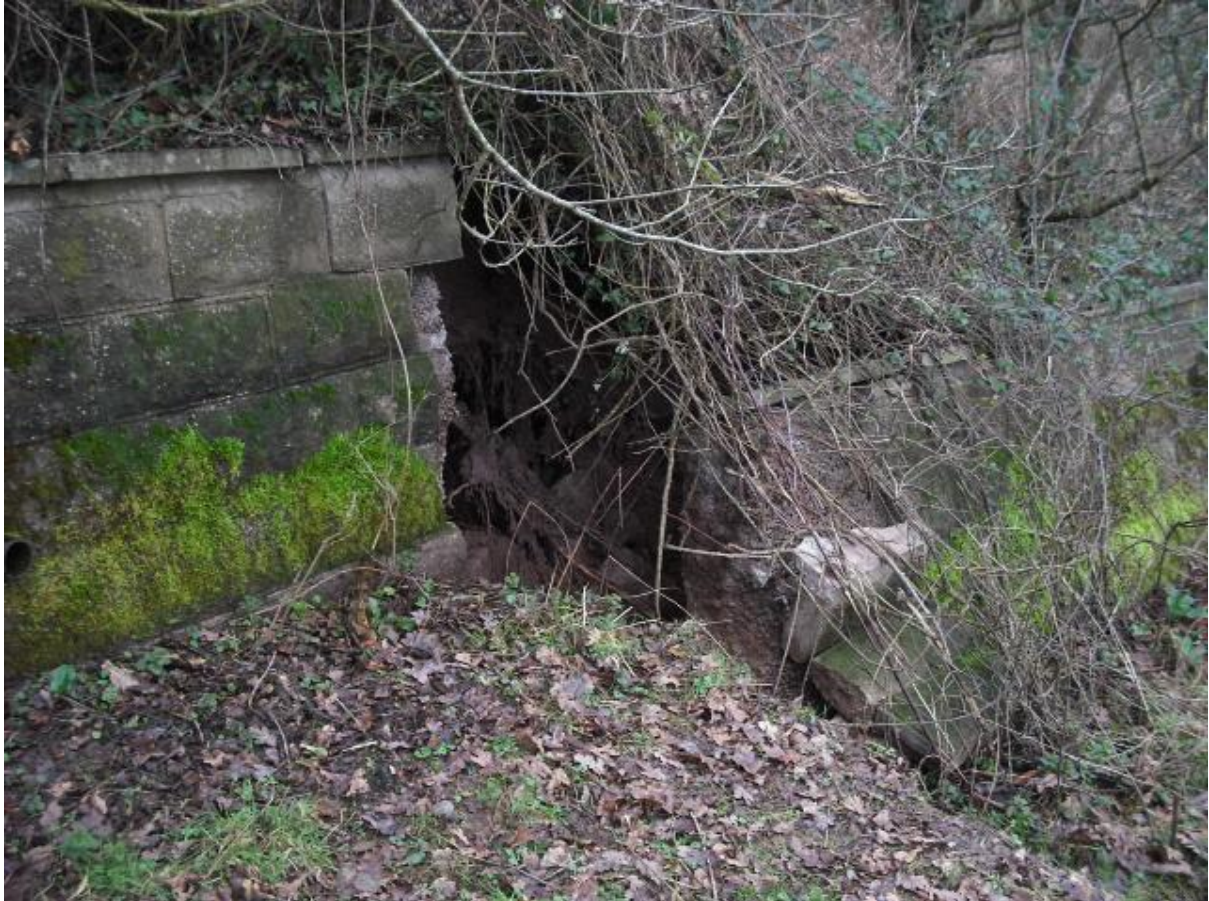
Detail of damage

The extent of the ground movement can be clearly seen in this photograph

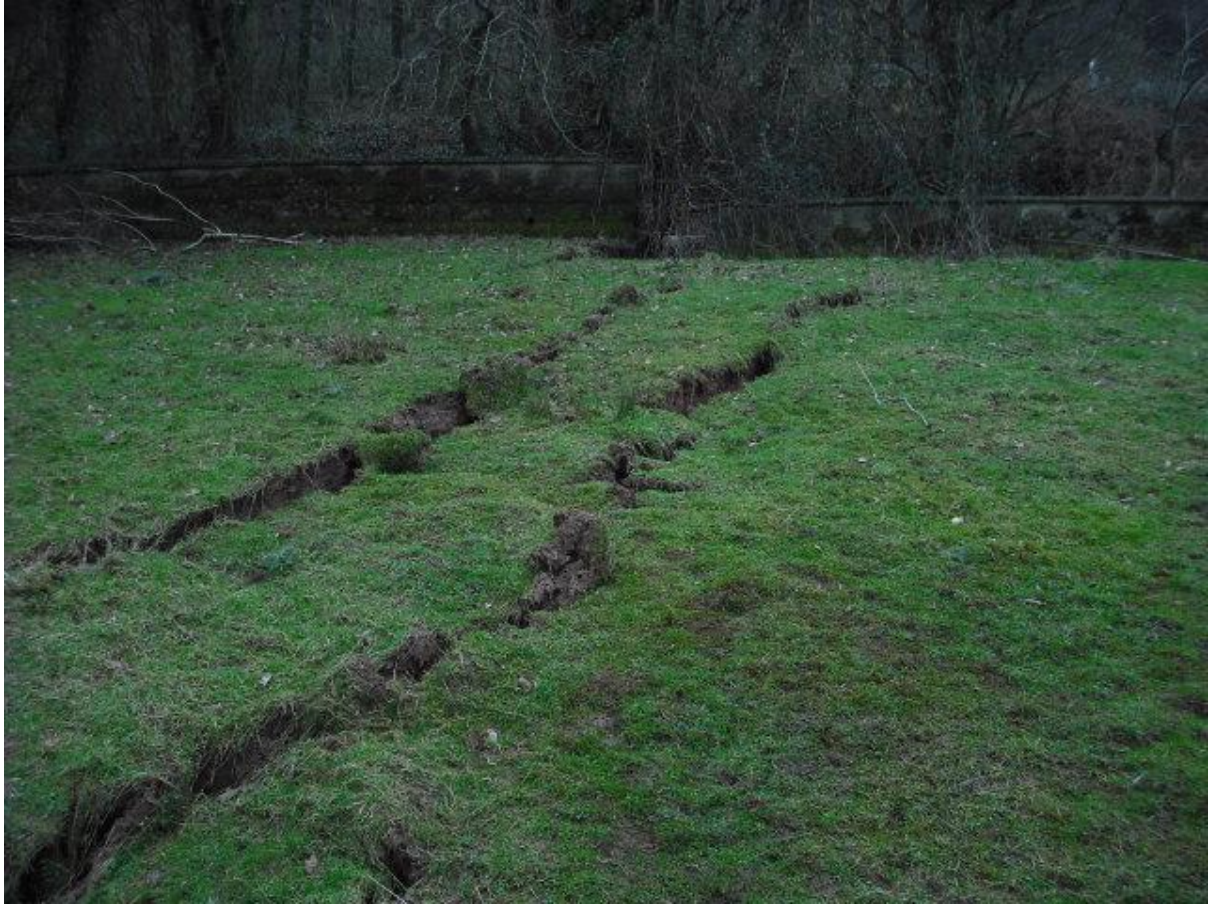
View of retaining wall showing extent of ground movement

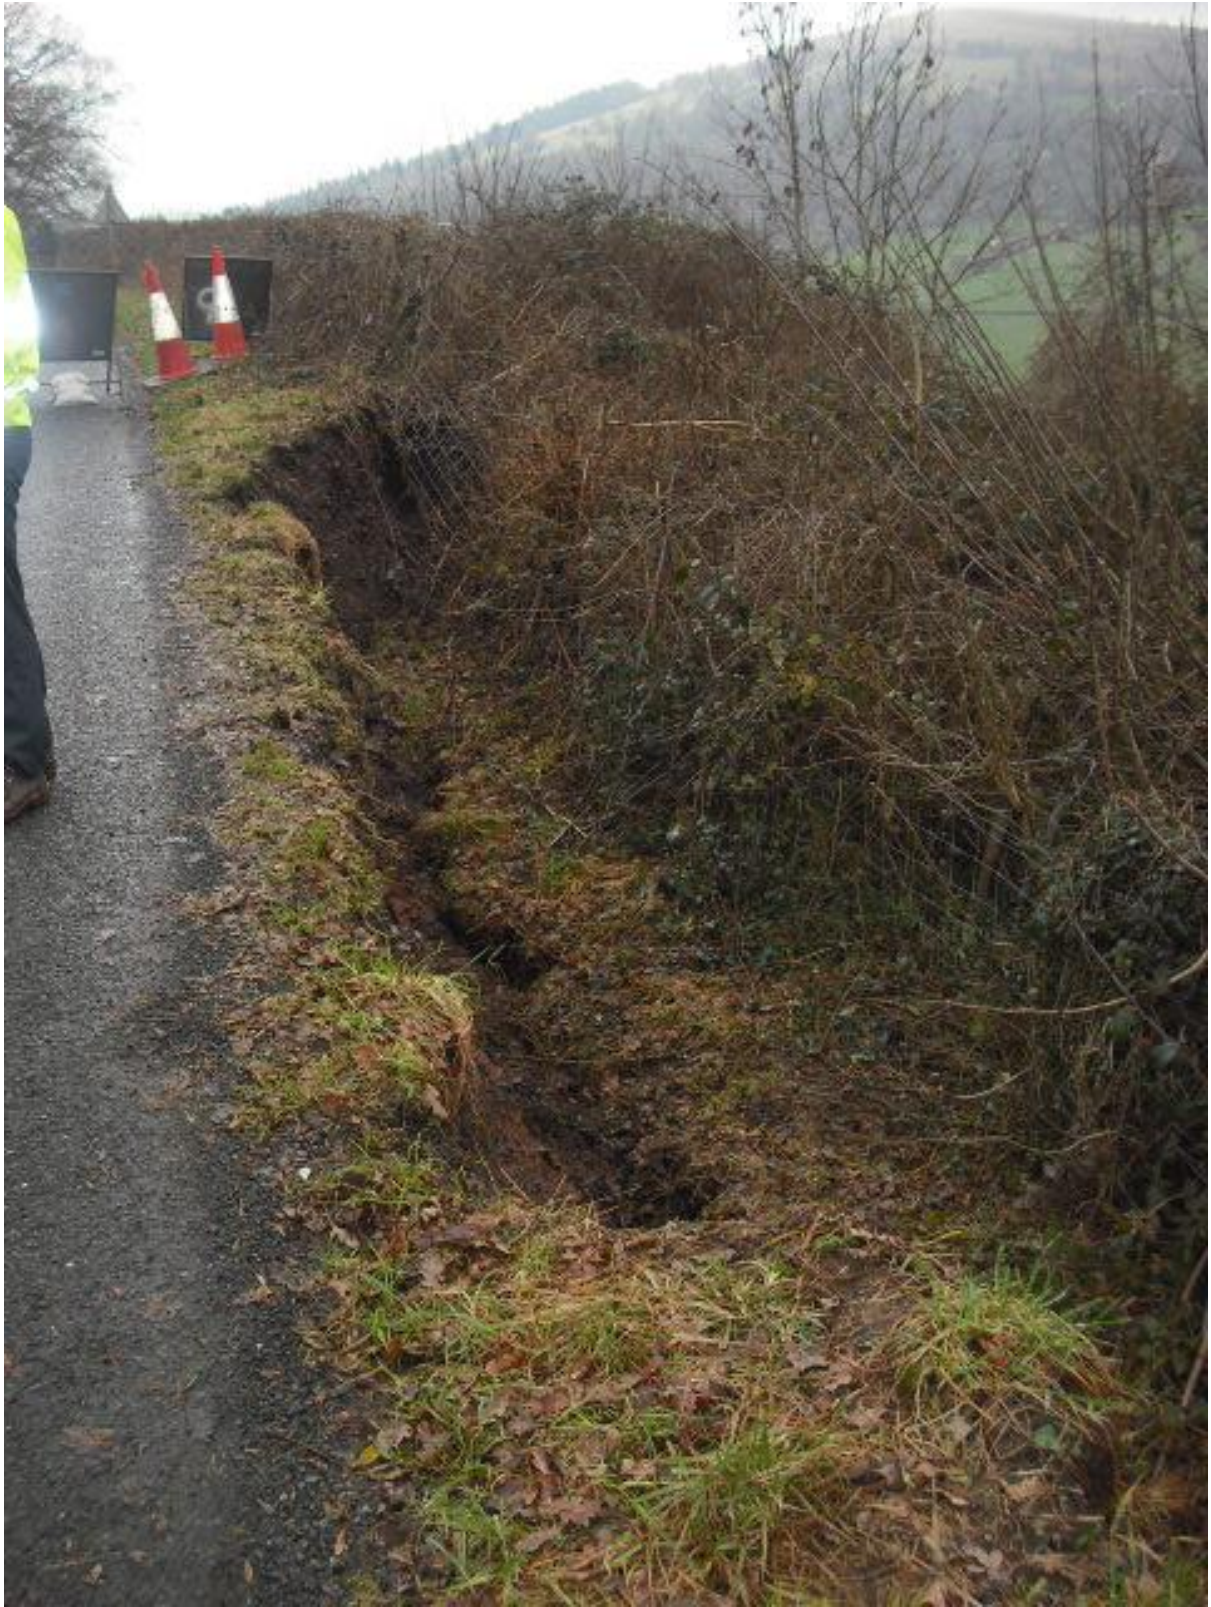
Ground movement at carriageway edge

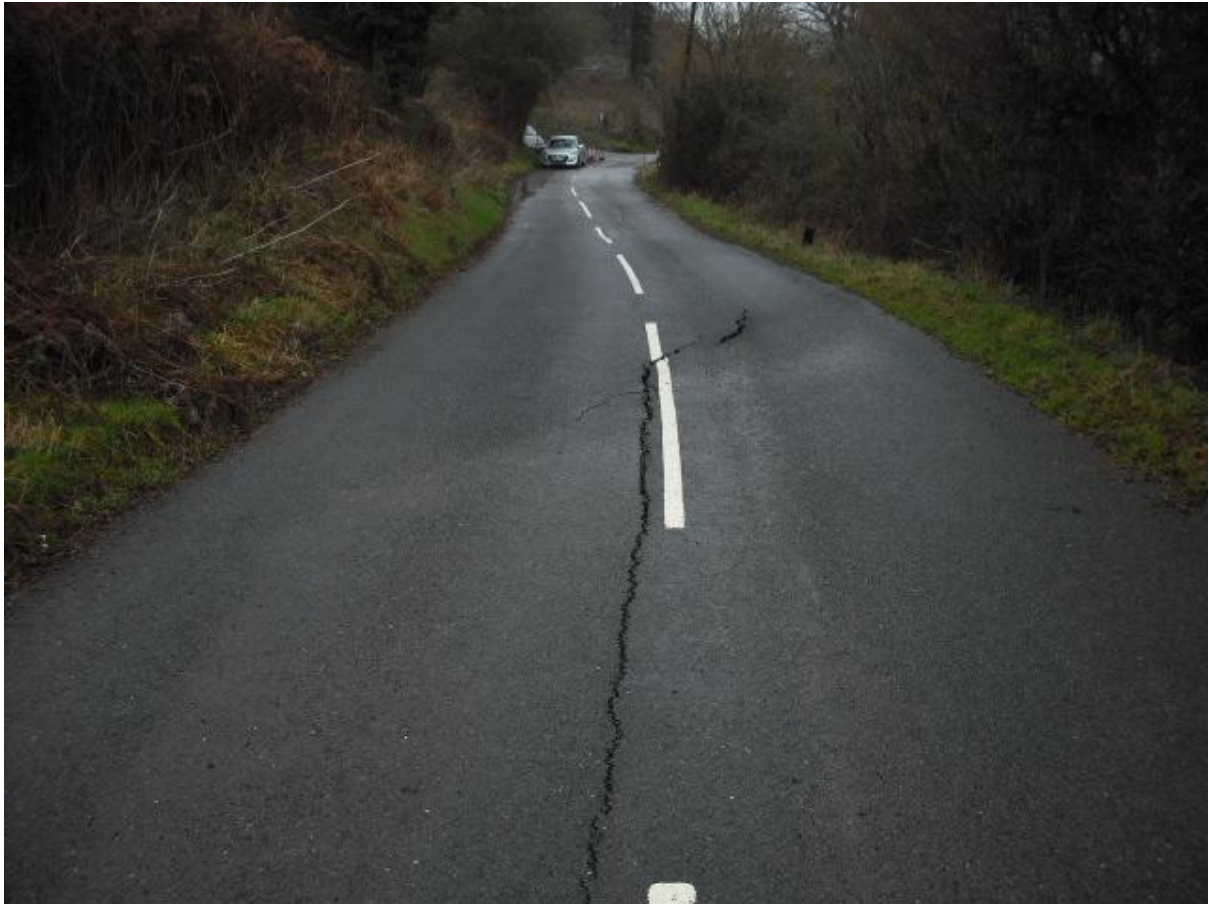
This section of the B4347 lies between White House Cottage and Dyffryn Cottages and whilst not as dramatic a failure as the other two areas it will still require a significant investment to repair the failure. The route is currently closed to traffic.

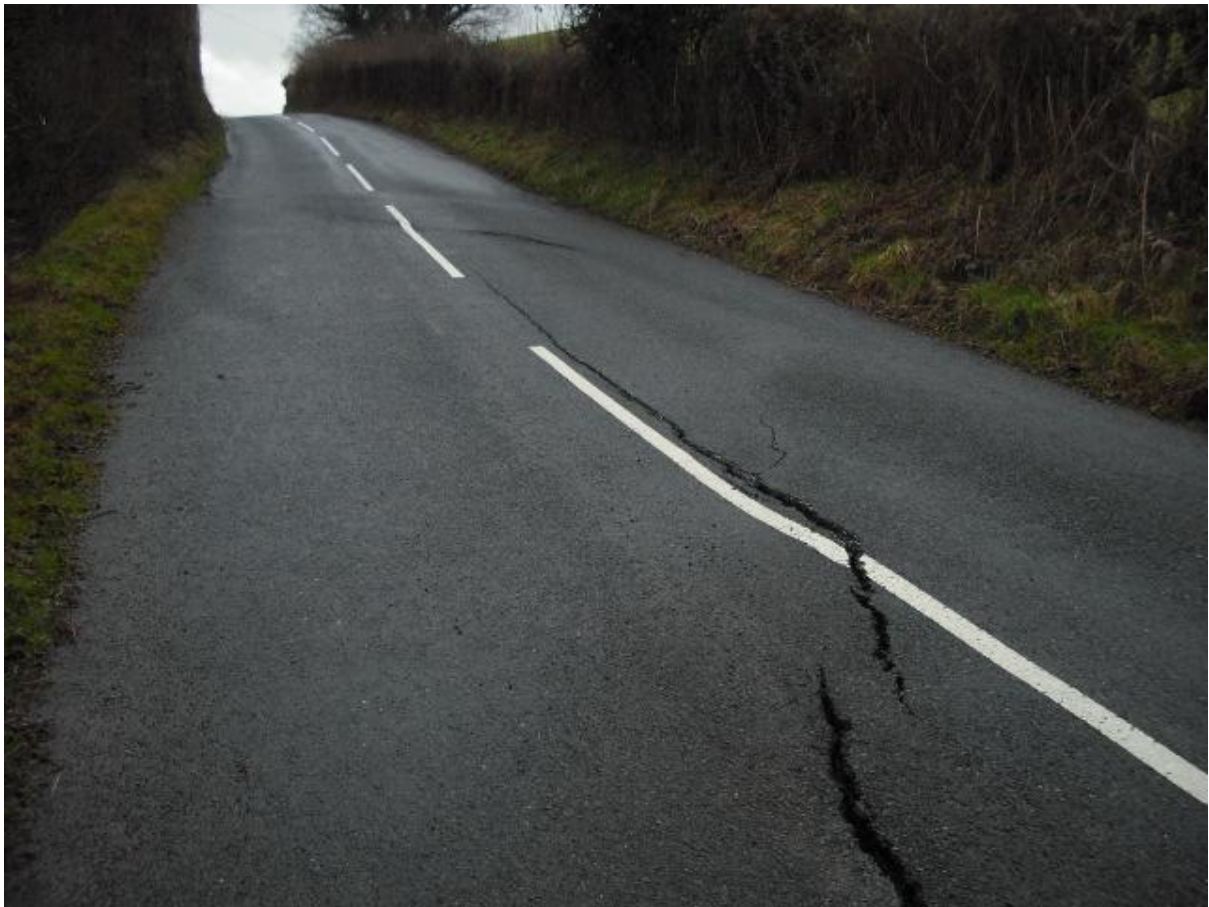
View looking South

The effect on the highway profile can clearly be seen with significant loss of support at the carriageway edge where the embankment has slipped away. Likely repair costs for this section of the B4347 are Circa £60,000

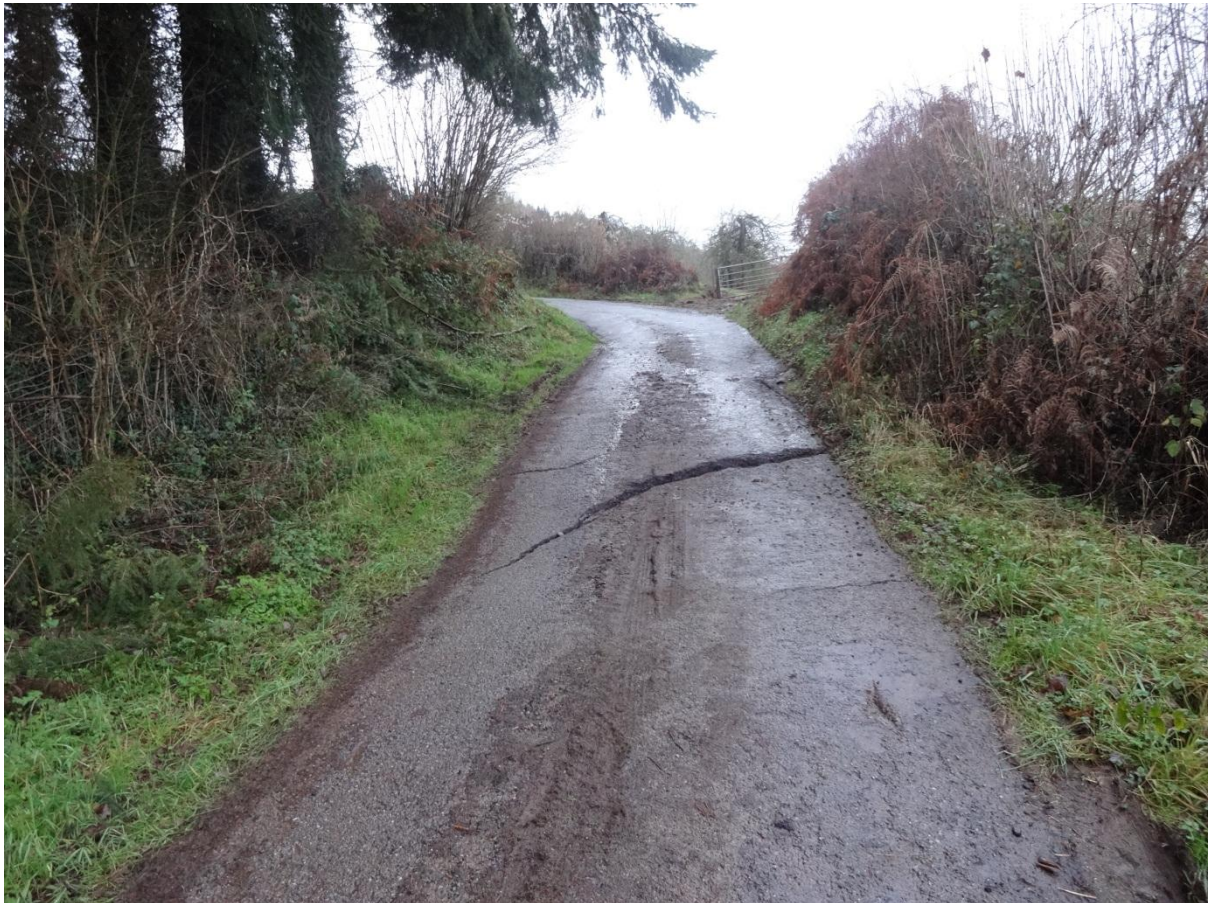
View looking North

On the R38 at Ruthlin Mill the tension cracking is clearly evident. However the slip zone extends above and below the carriageway affecting orchards on the up slope and third party structures downslope. The route is closed to traffic. Budget costing for the required works is £46,000

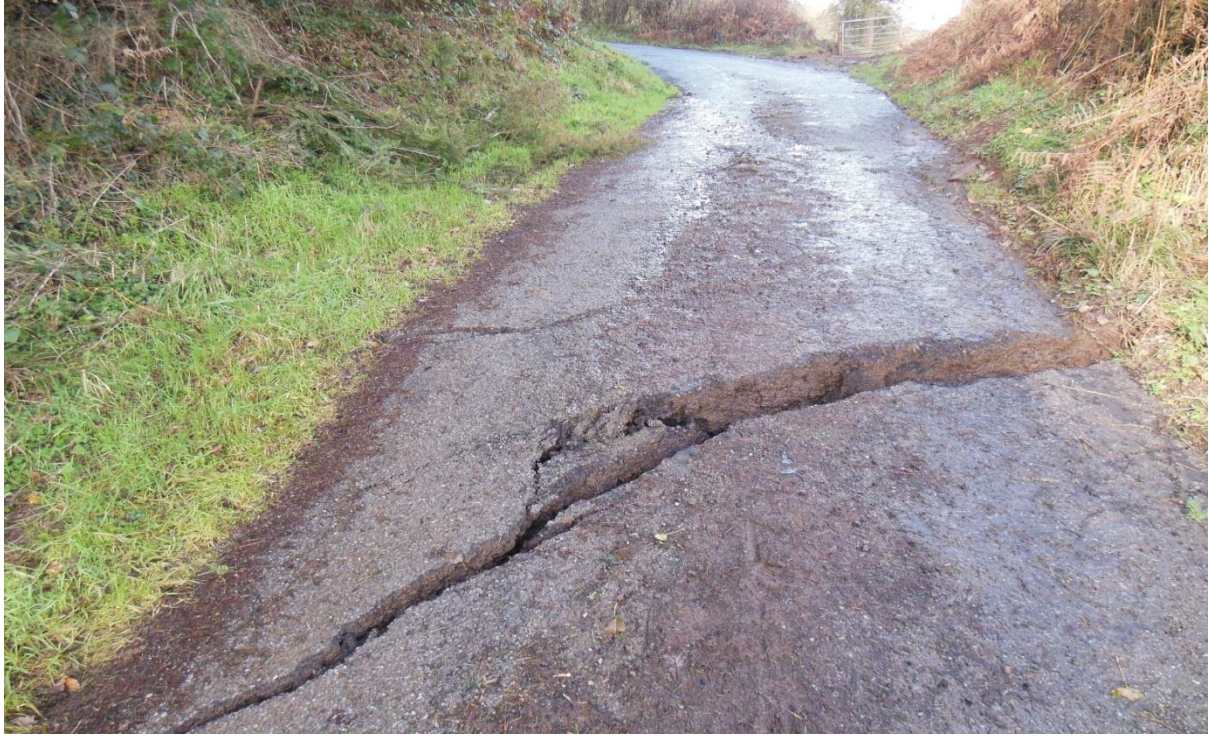
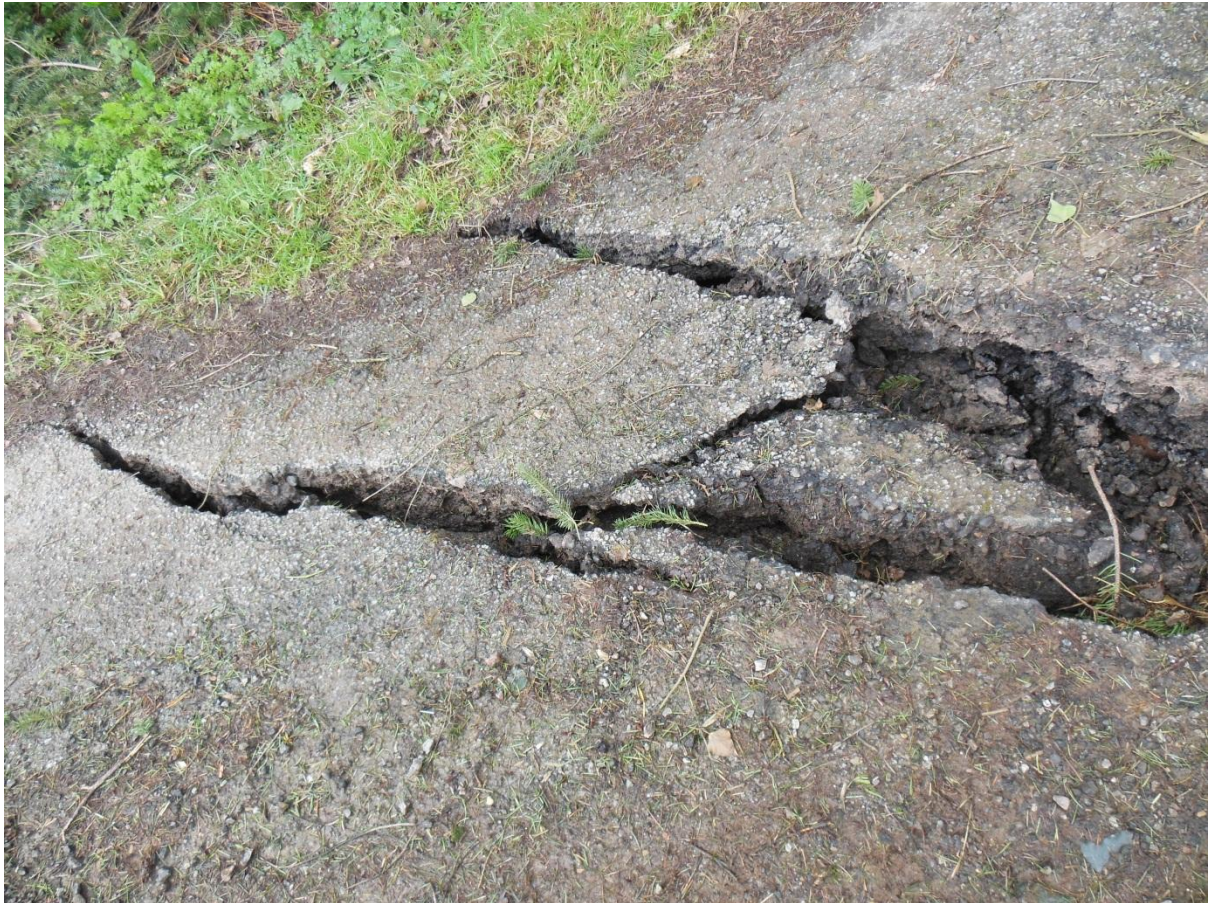
Views looking North

Close up of Tension cracking at Ruthlin Mill

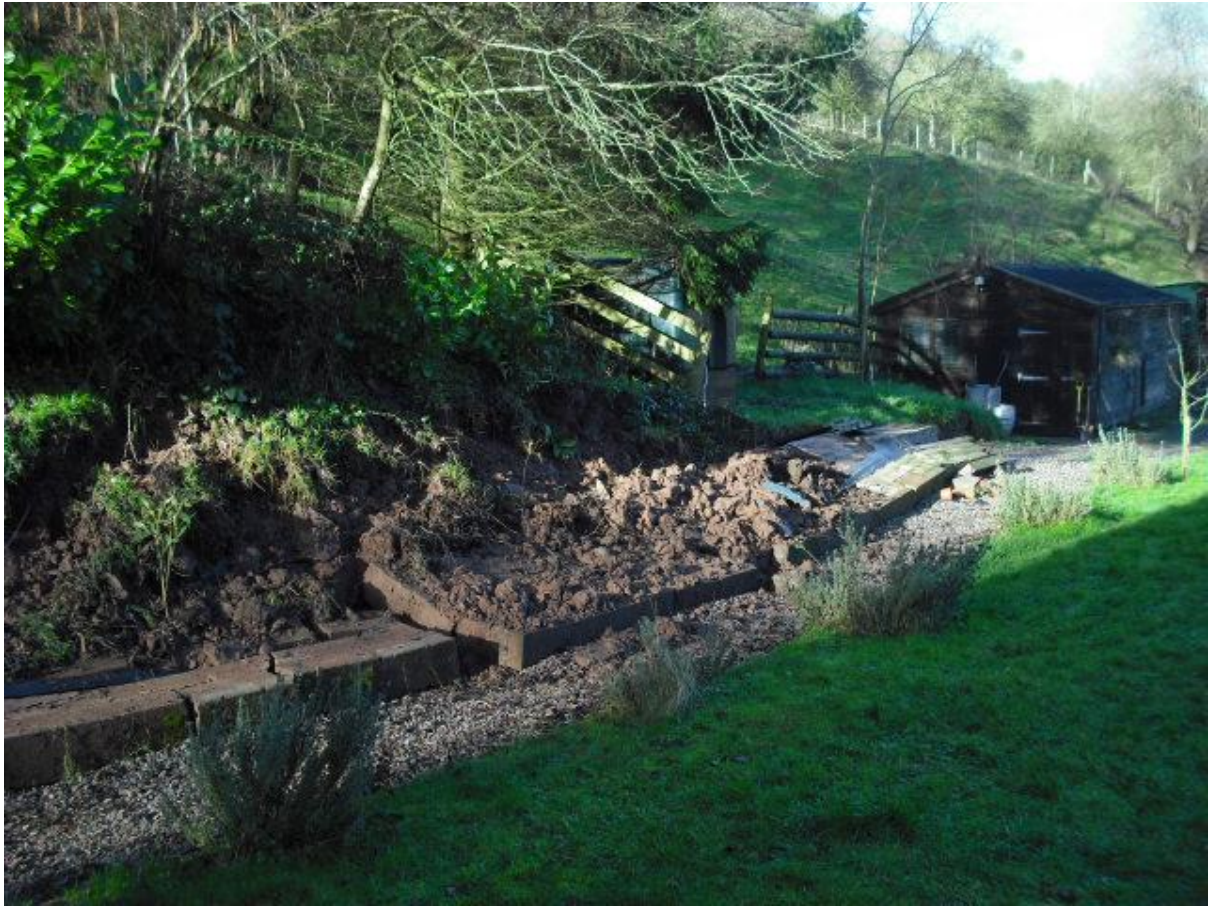
Effect on third party structure at Ruthlin Mill
downslope of carriageway

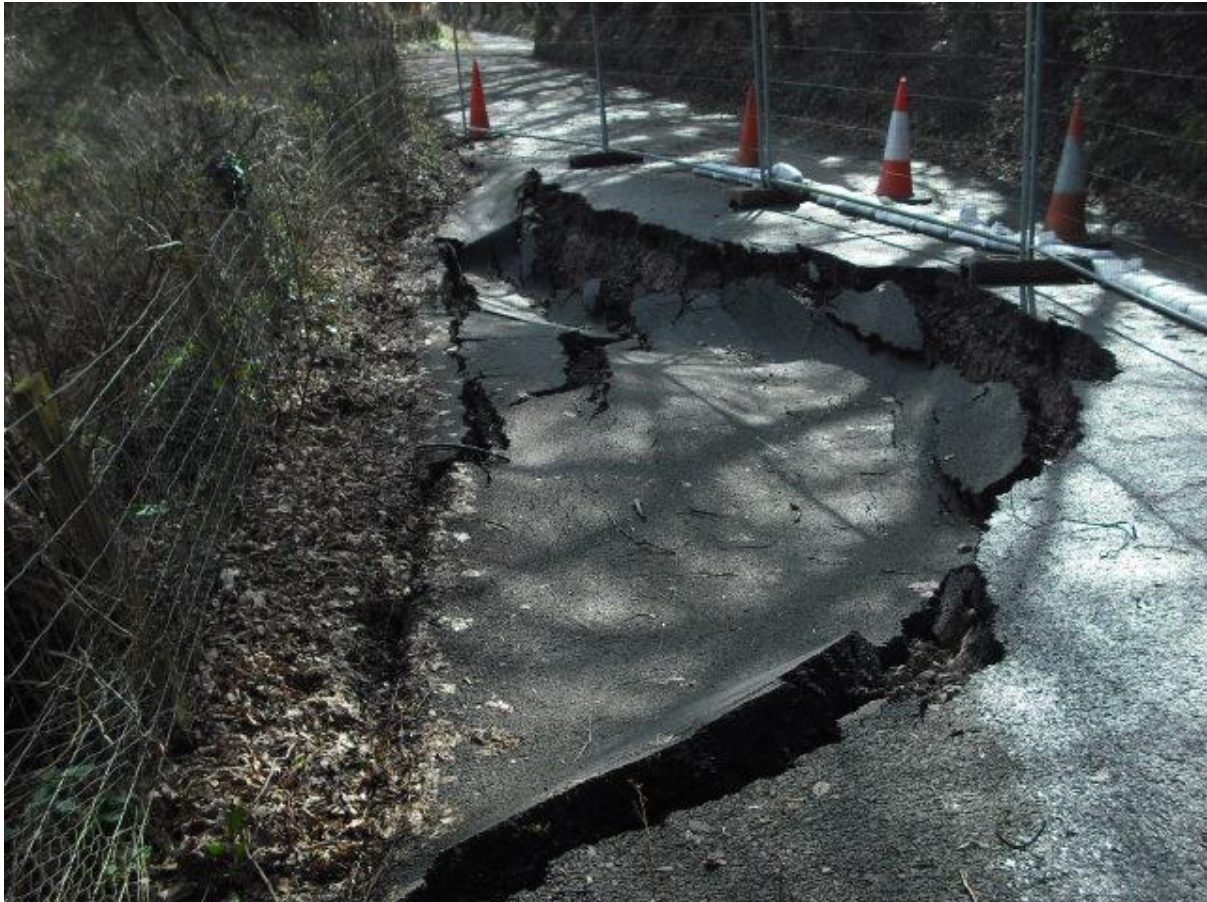
View looking South

An extensive slip area has formed on route R35 requiring the carriageway to be closed to traffic. The carriageway is affected over a length of some 20.0m and a shift in level approaching of 0.6m is present. Likely repair cost will be in the order of £71,000.

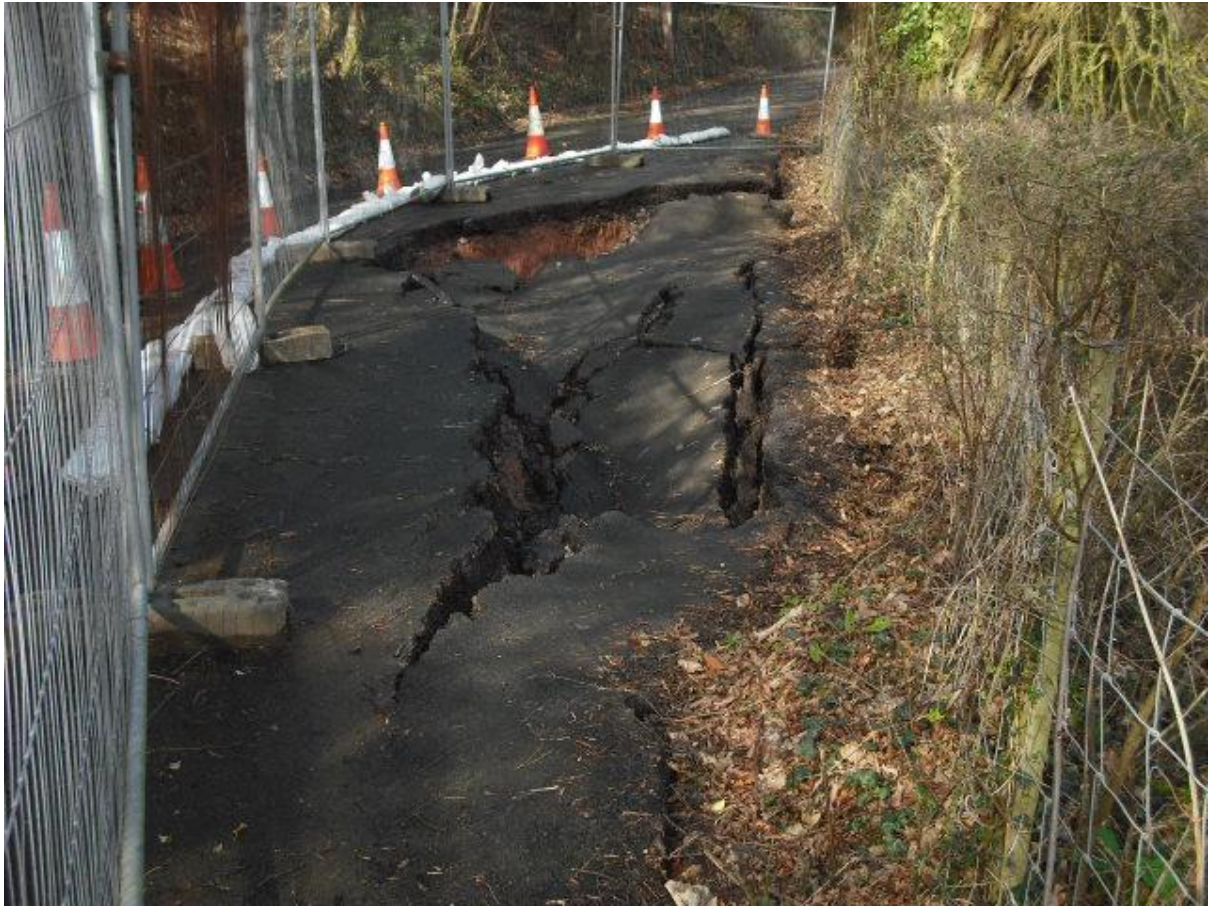
View looking North

Detailed view of backscar highlighting vertical shift and exposure of the sub grade to weathering action

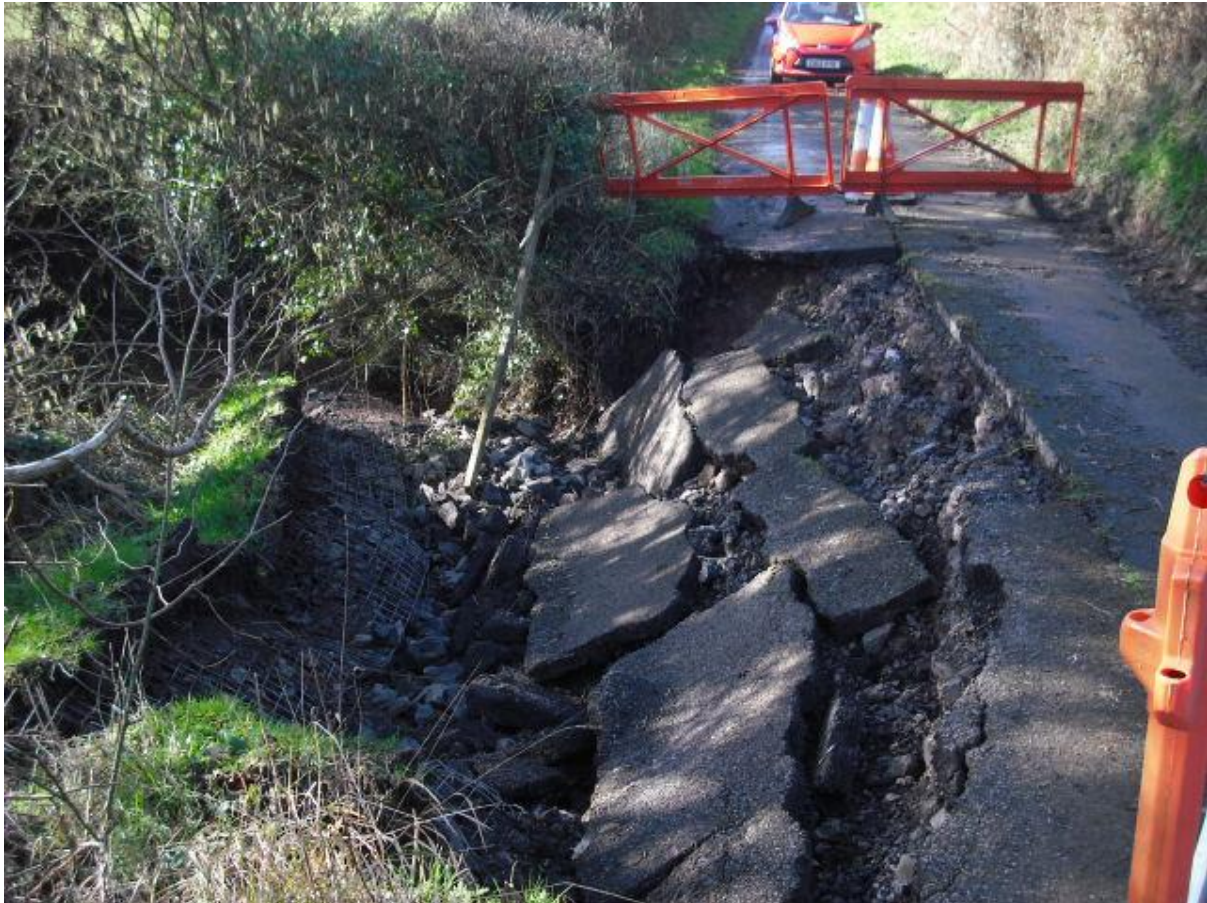
View looking West

Gabion Basket retaining wall undercut by stream resulting in collapse of retaining wall structure and carriageway. Route closed awaiting permanent repair approximate cost £25,000

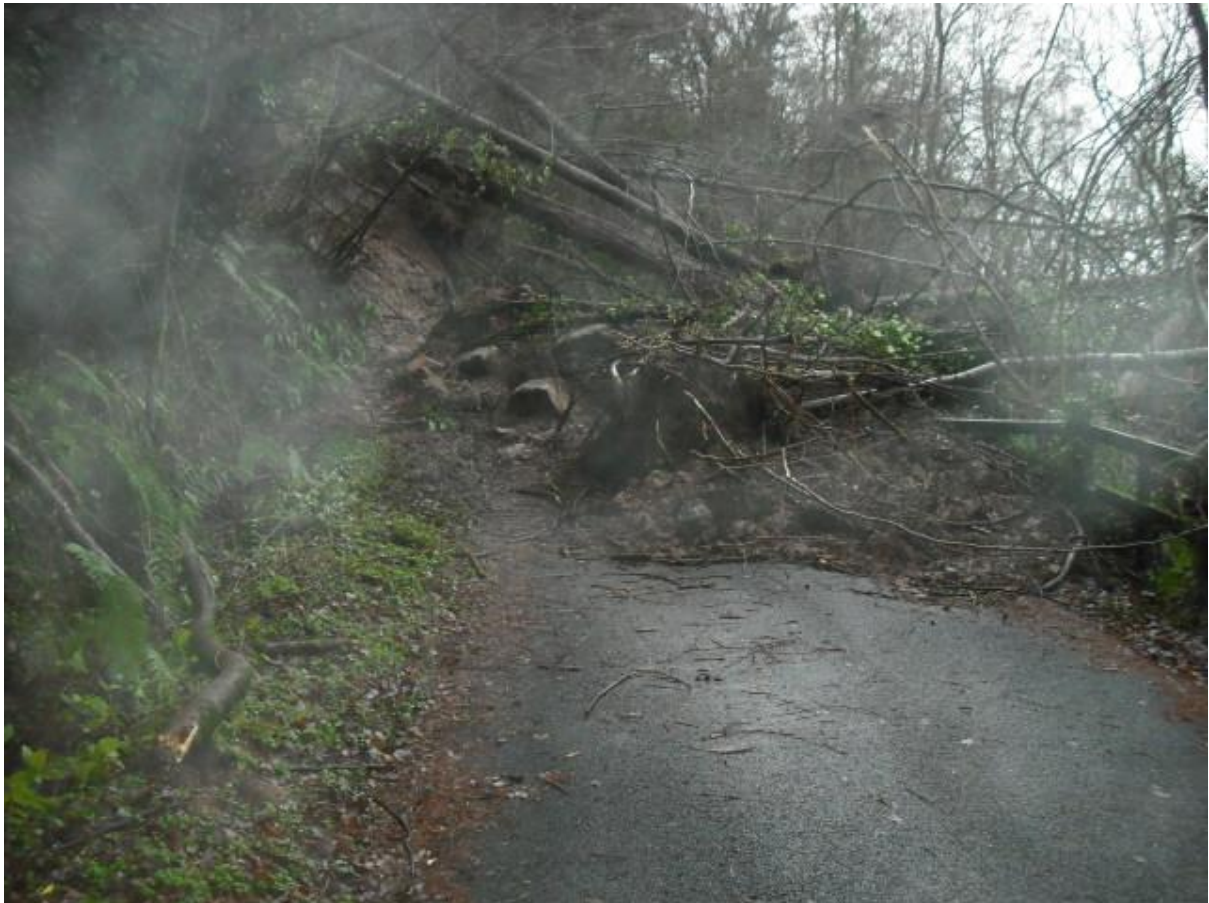
View looking North

The C48.1 local access road had to be closed when in excess of 750t of material including mature trees moved down slope. It was also necessary to close the popular Wye Valley walk which is a significant tourist attraction in order to protect the public. Both the road and footway remain closed. Repair costs are circa £32,000

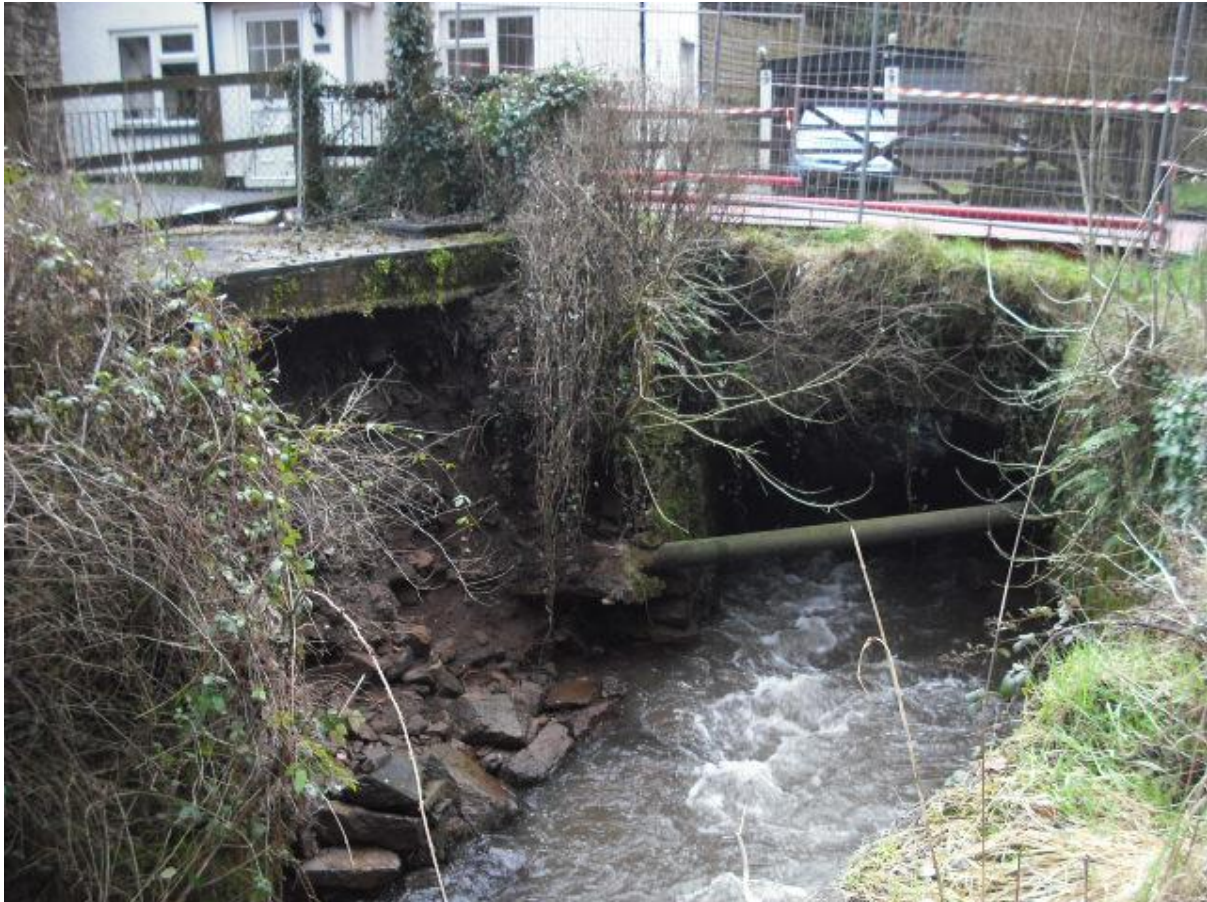
View looking East

The damage to the third party wing wall of the culvert can clearly be seen. This damage is representative of the damage suffered directly by the culvert structure upstream. A temporary bridge access has needed to be installed prior to permanent works being implemented. Lilely costs Circa £130,000

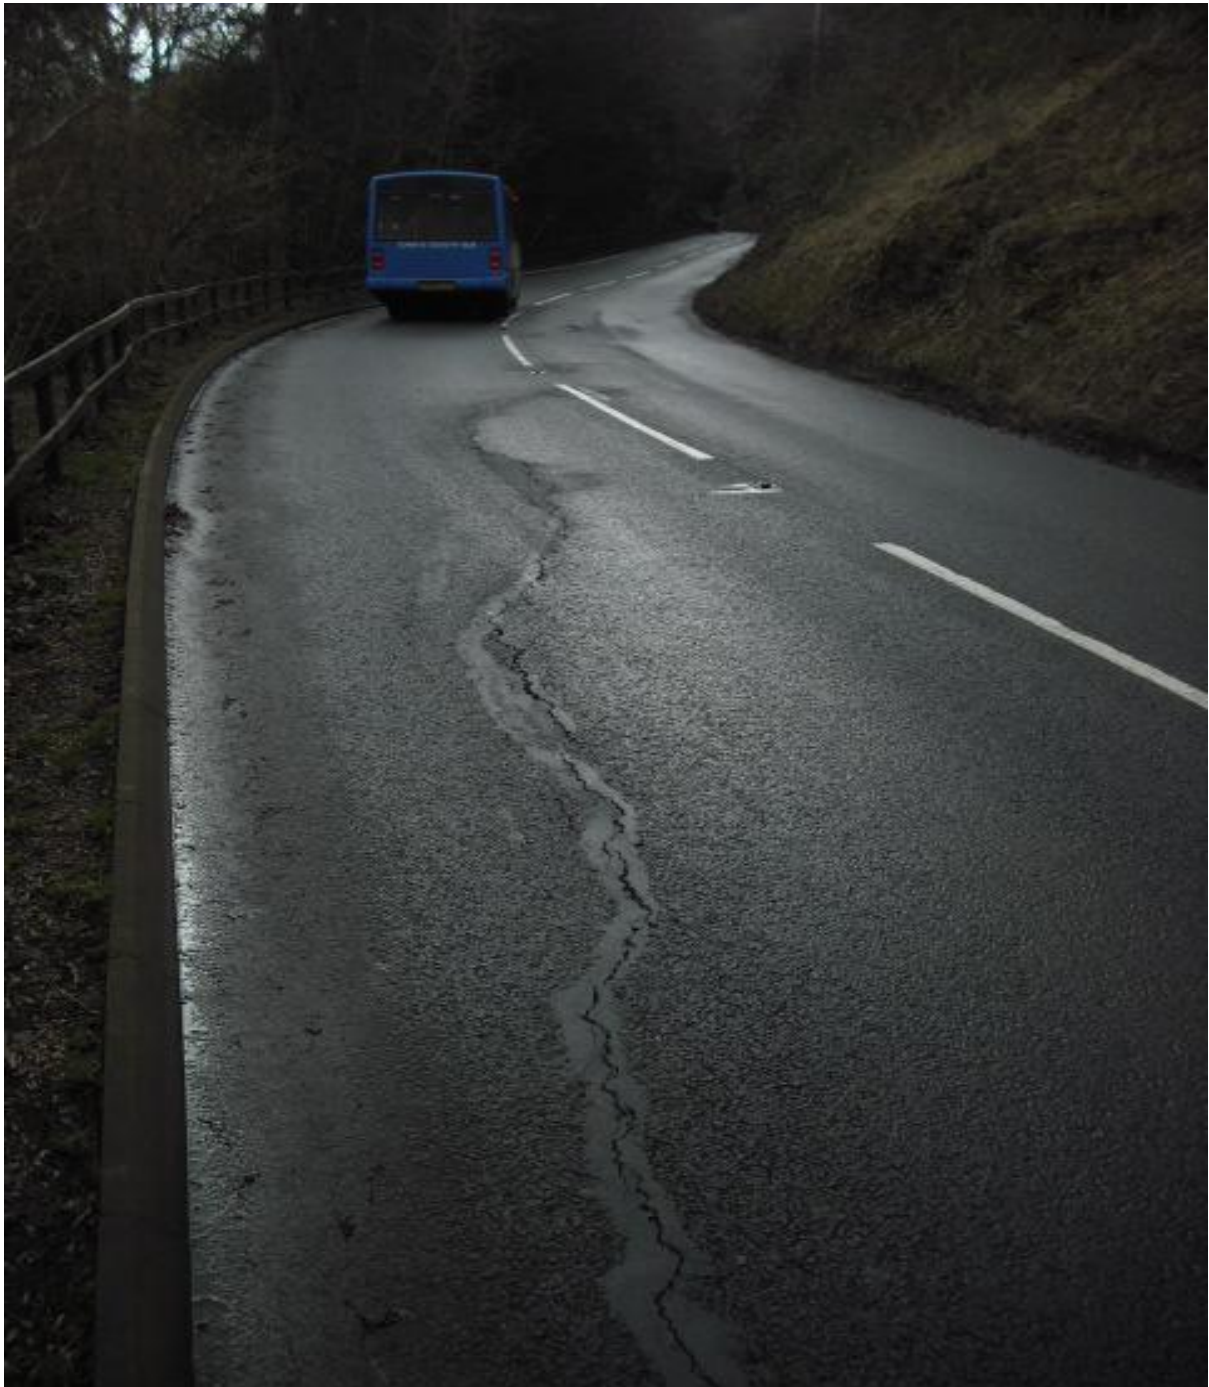
View looking South

Although the images are not dramatic the tension cracking that can be clearly seen within the carriageway extends for nearly 200m along the route and movement is

clearly taking place. The A466 has a history of ground movements due to the nature of the route construction and the geology of the area.
