monmouthshire
sir fynwy

Monmouthshire County Council
Review of Landslips within the County
December 2013- February 2014

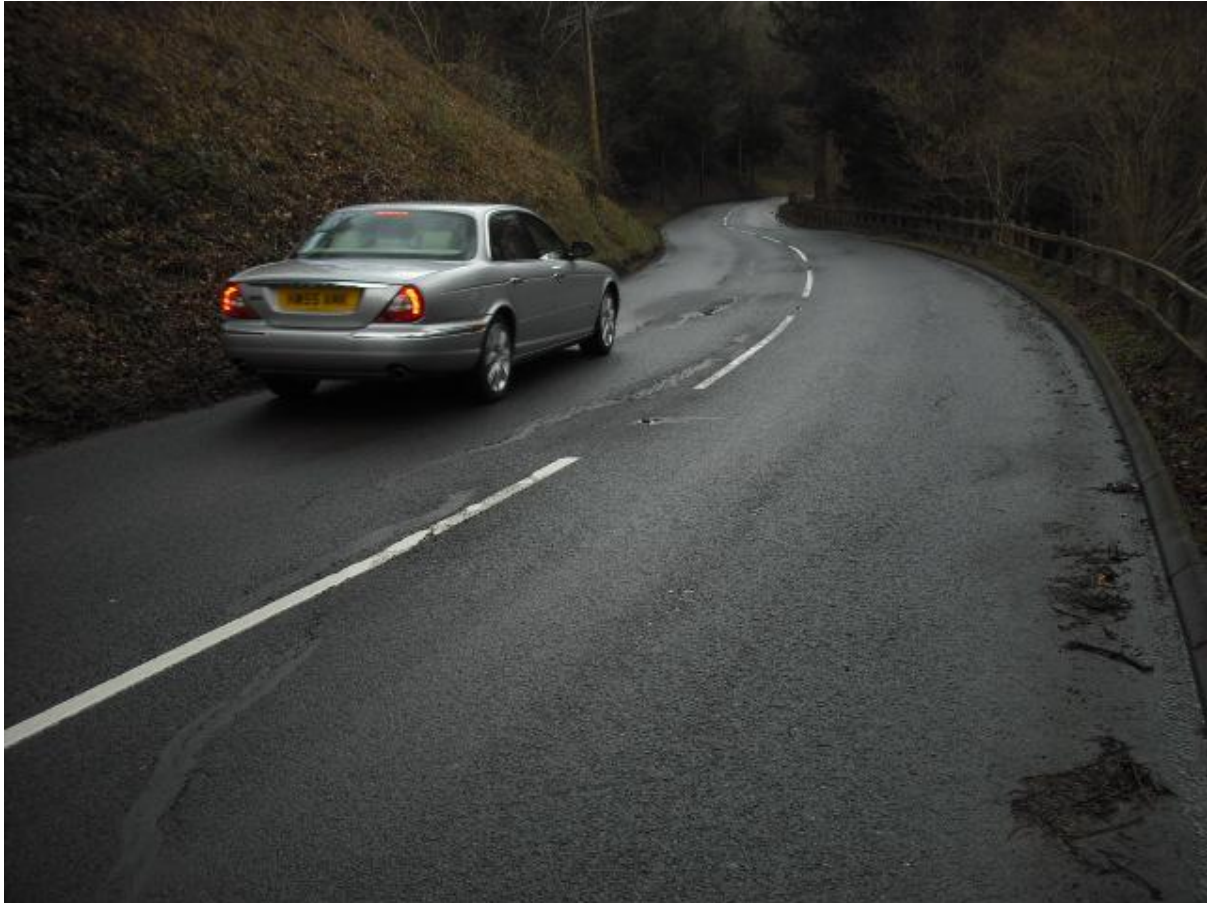
View looking North

Tension cracking can clearly be seen extending across the centreline of the A466. The scale of the potential problem and the probable method of repair indicates that some £535,000 may be required to effect a solution here.

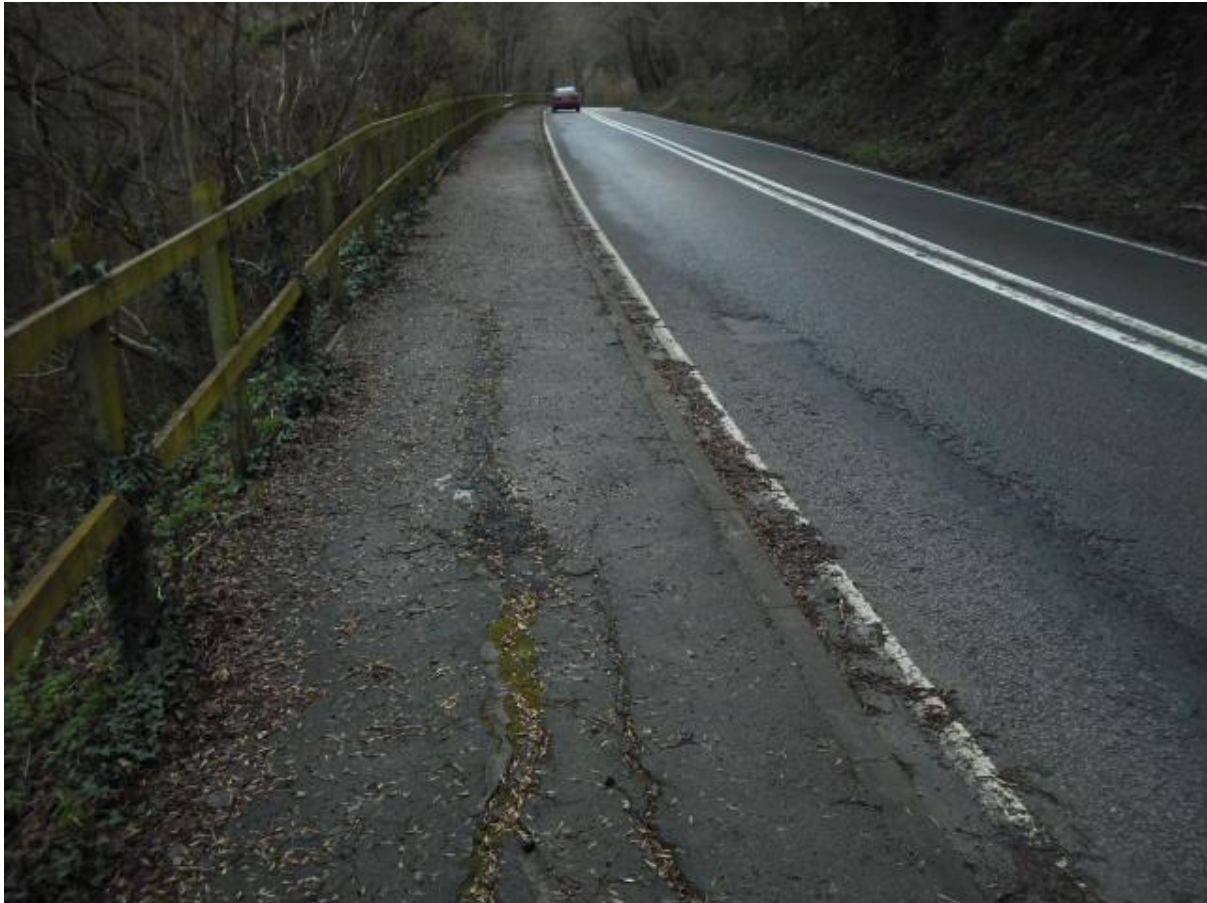
View looking South

The image shows a typical failure of the carriageway footpath which runs intermittently for 130m over a length of some 280m. Budget costings for the repair works are Circa £263,000

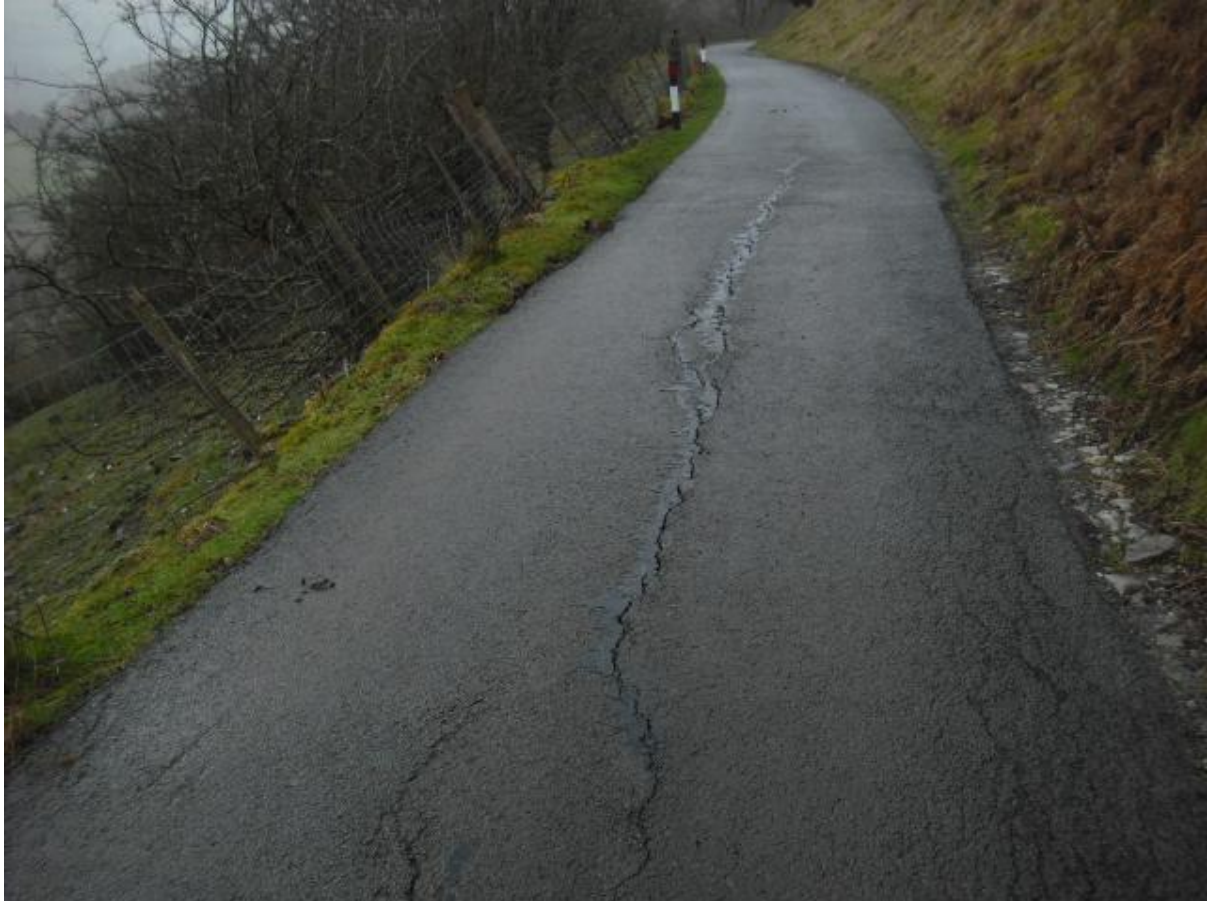
View looking West

The Tension cracking within the carriageway runs for some 50m and the movement of material downslope can be seen in the attitude of the adjacent fence line. Repair to the route may be in the order of £100,000
