monmouthshire
sir fynwy

Monmouthshire County Council
Review of Landslips within the County
December 2013- February 2014

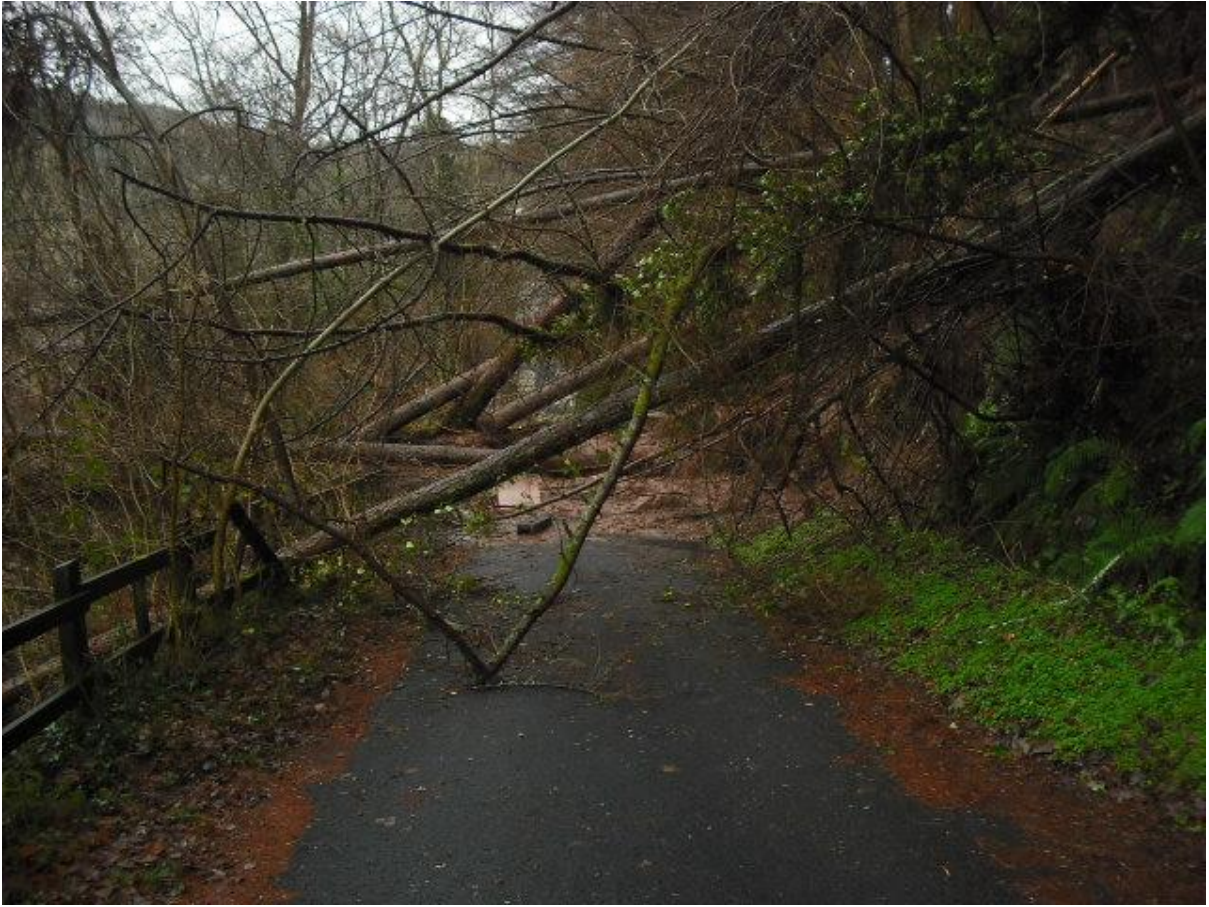
View looking South along route

The C48.1 local access road had to be closed when in excess of 750t of material including mature trees moved down slope. It was also necessary to close the popular Wye Valley walk which is a significant tourist attraction in order to protect the public. Both the road and footway remain closed. Repair costs are circa £32,000

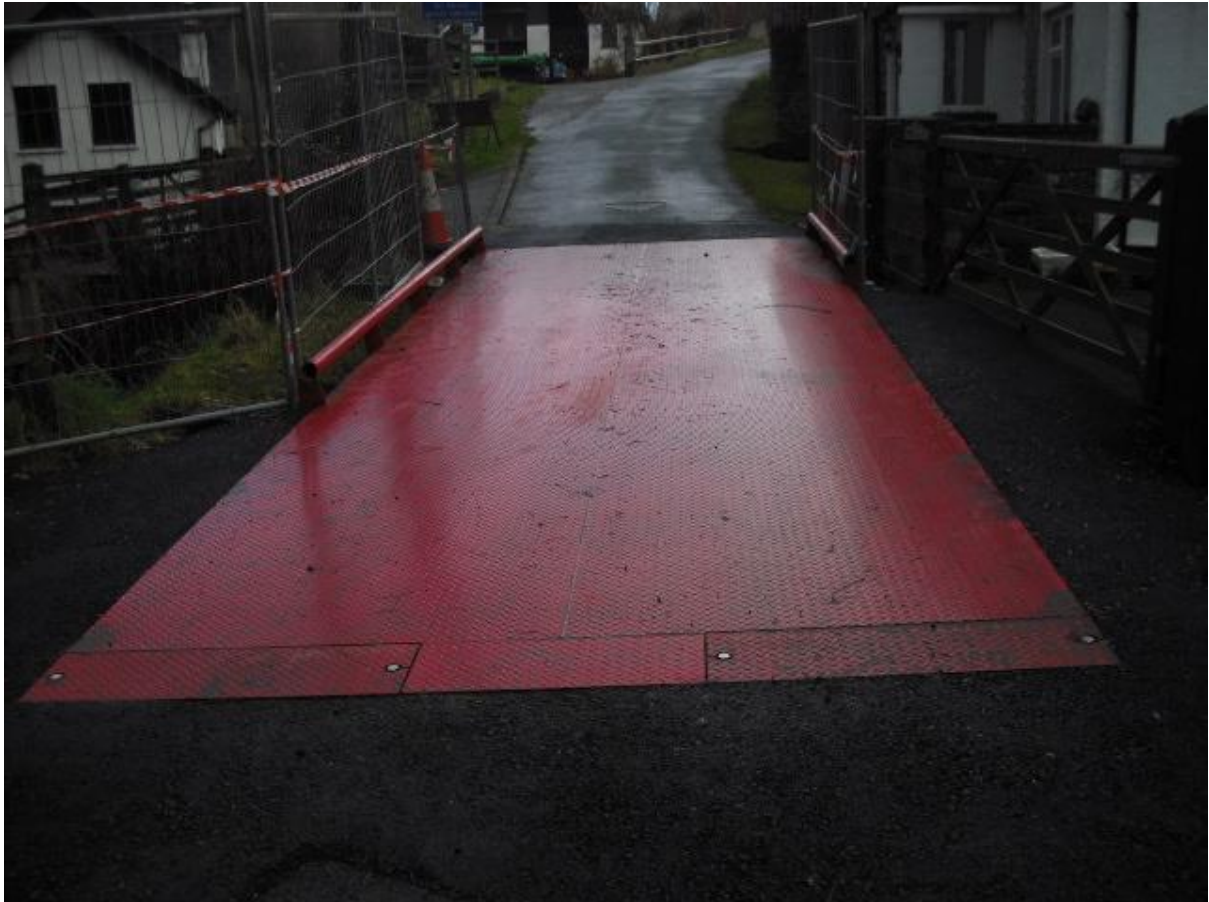
Temporary Bridge Access

The damage to the third party wing wall of the culvert can clearly be seen. This damage is representative of the damage suffered directly by the culvert structure upstream. A temporary bridge access has needed to be installed prior to permanent works being implemented. Lilely costs Circa £130,000
